DEPARTMENT OF TRANSPORTATION

Contract #: 04-0120F4Cty: SF/ALA Rte: 80 PM: 13.2/13.9File #: 69.28**WELDING INSPECTION REPORT****Resident Engineer:** Pursell, Gary**Address:** 333 Burma Road**City:** Oakland, CA 94607**Report No:** WIR-007358**Date Inspected:** 03-Jun-2009**Project Name:** SAS Superstructure**OSM Arrival Time:** 1845**Prime Contractor:** American Bridge/Fluor Enterprises, a JV**OSM Departure Time:** 645**Contractor:** Zhenhua Port Machinery Company, Ltd (ZPMC), Changxing Island **Location:** Shanghai, China**CWI Name:** Wu Zhi Cheng**CWI Present:** Yes No**Inspected CWI report:** Yes No N/A**Rod Oven in Use:** Yes No N/A**Electrode to specification:** Yes No N/A**Weld Procedures Followed:** Yes No N/A**Qualified Welders:** Yes No N/A**Verified Joint Fit-up:** Yes No N/A**Approved Drawings:** Yes No N/A**Approved WPS:** Yes No N/A**Delayed / Cancelled:** Yes No N/A**Bridge No:** 34-0006**Component:** OBG**Summary of Items Observed:**

OBG Trial Assembly Area-

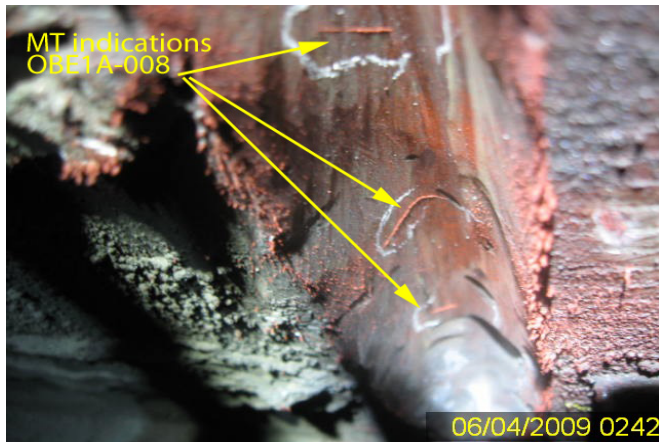
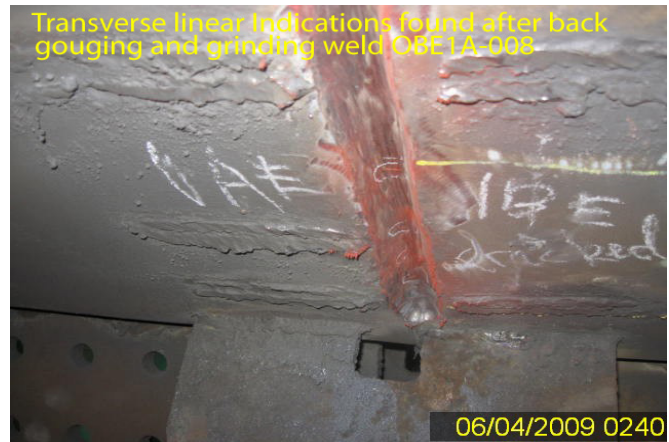
During random visual inspection of OBG segment 1AE to 1BE exterior Bottom Plate for complete joint penetration weld OBE1A-008. And after completion of back gouging and grinding in preparation for welding on the exterior surface of the weld, nine (9) transverse linear indications were observed. The 9 indications ranged in length from 3 mm to 15 mm. The transverse indications were shown to ZPMC and ABF QC Inspectors. Caltrans QA performed random Magnetic Particle inspection (MT) in the areas where the visual linear indications had been observed and these inspections confirmed the linear indications are rejectable. AWS D1.5 (02) Section 6.26.1.1 – “The weld shall have no cracks” ZPMC QC stated ZPMC would perform 100% MT of the exterior back gouge area. An incident was issued for the above mention defects.
